## INSPECTION REPORT

## MINERALS REGULATORY PROGRAM

REPORT DATE: MAY 7, 2019

Mine Name: Asphalt Ridge 2	Inspection Date: 05/07/2019 10:32 AM
Permit Number: M/47/0032	Inspection Time: 11:00 AM
Mine Status: Active	Inspector(s): April Abate
Operator Name: Tar Sands Holdings II	Prior Inspection: Jun 28, 2017
Attendee(s): A. Burrows, D. Hall, W. Campbell, . Novak, Div. Water Quality	Permit Fees: Paid
Weather: Sunny/Overcast	Bond Amount: \$792,000
Reviewed By:	Bond Escalation: Mar 2, 2016
Inspection Purpose: Routine inspection

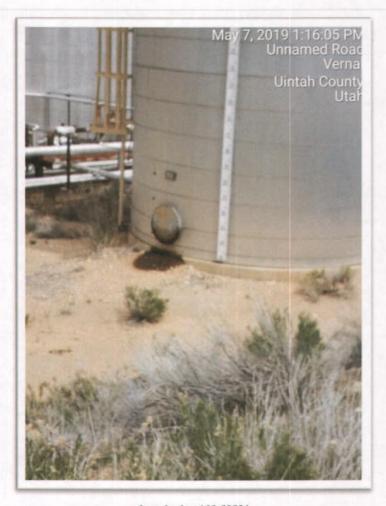
4. Deleterious Material	x : Evaluated
Comment: Small leak on one tank. Could not determine based or mixurebof both. Operator acknowleged it and will look into rem

Longitude: -109.59831
Latitude: 40.43629
Comment: Minor leak was oberved from one of the process tanks (approx. 1-2 gallons), below reportable qty

Conclusions and Recommendations: Site needs additional maintenance work on the seeps. Operator committed to maintenance on seeps by covering them with large boulders and to remediate leak from processs tank.

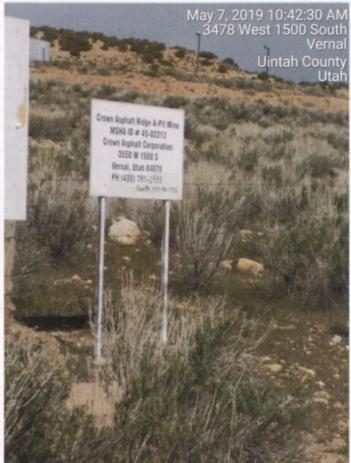
Longitude: -109.59550 Latitude: 40.43453 Comment: Entry sign

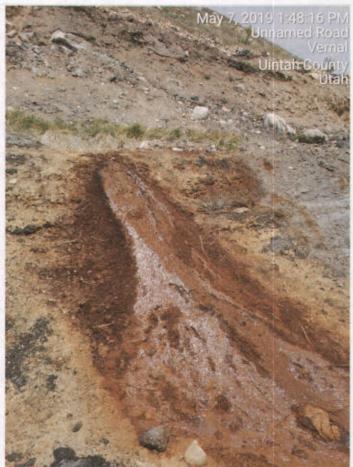
Longitude: -109.60018
Latitude: 40.43325
Comment: Example of active seep. Drains into mine pit. No offsite impact.

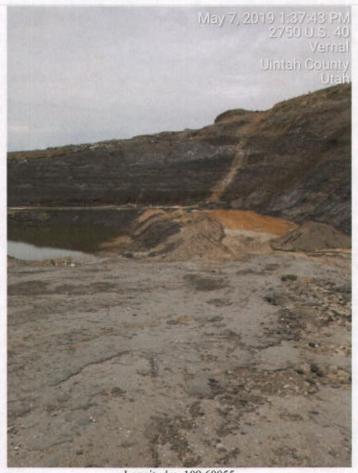
Longitude: -109.60055
Latitude: 40.43364
Comment: Stormwater was present in and near the main mine pit.

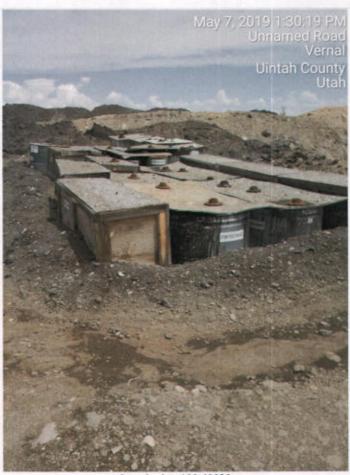
Comment: Scrap metal, salvaged equipment, crates and drums containing bitumen remain on the site in the boneyard areas.

Longitude: -109.60039
Latitude: 40.43402
Comment: Bitumen product containers located on the property.

Should be cleaned up and taken offsite for proper disposal if no future use is planned.
